**Flood Control Project Maintenance
Levee Inspections**
LMA District Cover Sheet
Spring 2019 Levee Inspection Results

Sacramento Maintenance Yard Willow Slough Bypass

Spring 2019 Levee Inspection Results

Waterway			Bank	Unit Miles
Unit No. 01 Willow Slough Bypass or North Levee			Left	5.05
	Spring (March - May)	Summer (June - August)	(September - November) Fall	Winter (December - February)
Unit Maintenance Rating (Fall Only)				
Date of Inspection	4/30/2019 - 4/30/2019			
DWR Inspector	Zach Jojola			
Accompanied By

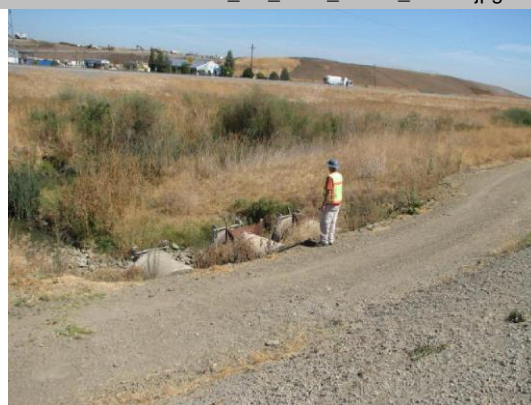
Photo 2 of 3 : UCIP_SP_2019_45294_22788.jpg

Waterside overview-

Comment Code						
Inspector Comment						
FS_ID:45294						
DS_ID:541						
EP_NO: 10335						
Repair Type: No Action Needed						
Crossing Status: Found						
UCIP Comments: 09/20/2012 Landside view photos are missing.						
Daylight pipe is a steel pipe. The pipe through the levee may be a CMP.						
(DWR UCIP - P. Amatya)						
FIELD_STRUCT_DESC: 1 of 2. 42-inch corrugated metal drainage pipe						
through the levee, 12 feet below the crown. Flap gate located on the						
waterside (WS) end. 42-inch pipe sleeved through a 48-inch corrugated						
metal pipe (CMP). (two 48-inch pipes [HLM 3.54] authorized under						
Automatic Board Order (ABO) issued as Permit No. 10335, 1974 -						
Snyder). [Additional Reference(s): DWR Levee Log, 1990. USACE						
Sacramento O&M Manual Unit 120, Willow Slough Channel Relocation						
and Levee Construction, February 1947, (Station 192+80)]						
FS Date: 5/14/2015 1:41:55 PM

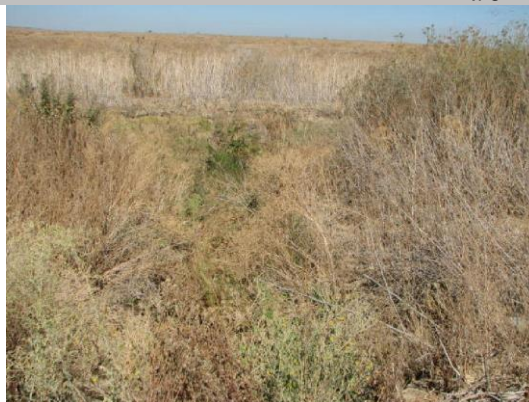
Photo 2 of 3 : UCIP_SP_2019_45298_22804.jpg

Comment Code					
Inspector Comment					
FS_ID:45298 DS_ID:545 EP_NO: 10334 Repair Type: No Action Needed Crossing Status: Found UCIP Comments: 04/12/2017 WS - good/clear, LS - good/clear needs to be cut and sprayed, inspected by JK, RF. (DWR Sacramento Yard - C. Lund) 05/24/2013 Rodent activities on headwall is far from the levee. Inlet is across city of davis drainage ditch. Inlet was cleaned last fall. see picture. (DWR Sacramento Yard - C. Lund) 09/20/2012 May need video inspection as seen rodent activities on headwall. (DWR UCIP - P. Amatya) FIELD_STRUCT_DESC: 24-inch corrugated metal drainage pipe through the levee, 13.5 feet below the crown. Flap gate is located on the waterside (WS) end. (24-inch pipe [HLM 4.21] authorized under Automatic Board Order (ABO) issued as Permit No. 10334 - Rhinehart) [Additional Reference(s): DWR Levee Log, 1990. USACE Sacramento O&M Manual Unit 120, Willow Slough Channel Relocation and Levee Construction, February 1947, Drawing No. 50-4-2281 Sheet 2 (Station 228+46)] FS Date: 5/14/2015 1:43:00 PM

Landside overview

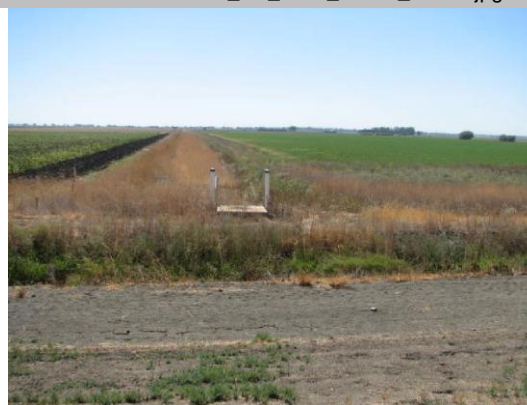
Photo 1 of 3 : UCIP_SP_2019_45301_22845.jpg

Comment Code					
Inspector Comment					
FS_ID:45301 DS_ID:548 EP_NO: 10321 Repair Type: No Action Needed Crossing Status: Found UCIP Comments: 04/12/2017 WS - good/clear, inspected by JK, RF. (DWR Sacramento Yard - C. Lund) FIELD_STRUCT_DESC: 24-inch drainage pipe through the levee, 17 feet below the crown. Flap gate is located on the waterside (WS) end. (24-inch pipe [HLM 4.97] authorized under Automatic Board Order (ABO) issued as Permit No. 10321, 1974 - Campbell) [Additional Reference(s): DWR Levee Log, 1990. USACE Sacramento O&M Manual Unit 120, Willow Slough Channel Relocation and Levee Construction, February 1947, Drawing No. 50-4-2281 Sheet 4 (Station 268+57)] FS Date: 5/14/2015 1:44:17 PM

Landside view- overview

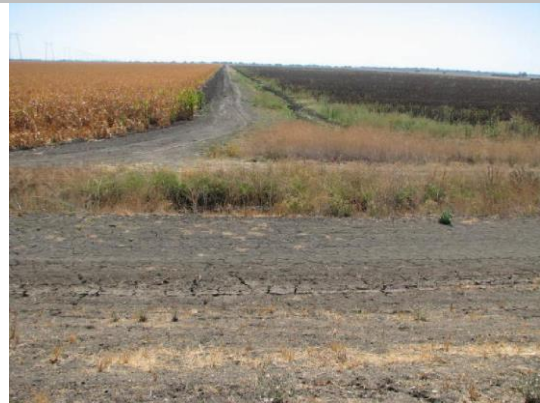
Photo 1 of 3 : UCIP_SP_2019_45302_22849.jpg

Comment Code					
Inspector Comment					
FS_ID:45302 DS_ID:549 EP_NO: 10322 Repair Type: No Action Needed Crossing Status: Found UCIP Comments: 04/12/2017 WS - submerged in water, inspected by JK, RF. (DWR Sacramento Yard - C. Lund) FIELD_STRUCT_DESC: 24-inch corrugated metal drainage pipe through the levee, 17.5 feet below the crown. Flap gate is located on the waterside (WS) end. Concrete headwall with wing walls is located on WS. (24-inch pipe [HLM 5.32] authorized under Automatic Board Order (ABO) issued as Permit No. 10322, 1974 - Chew). [Additional Reference(s): DWR Levee Log, 1990. USACE Sacramento O&M Manual Unit 120, Willow Slough Channel Relocation and Levee Construction, February 1947, Drawing No. 50-4-2281 Sheet 4 (Station 287+19)] FS Date: 5/14/2015 1:44:30 PM

Landside view-overview

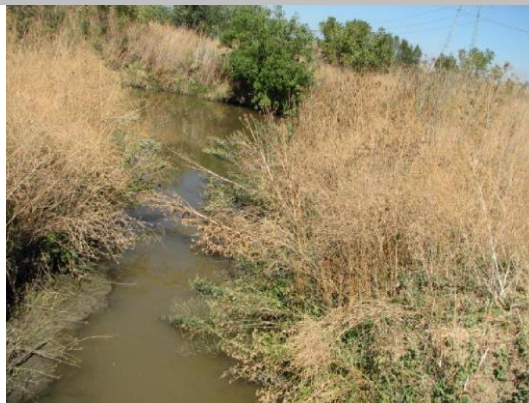
Photo 3 of 3 : UCIP_SP_2019_45302_22847.jpg

Comment Code						
Inspector Comment						
FS_ID:45302 DS_ID:549 EP_NO: 10322 Repair Type: No Action Needed Crossing Status: Found UCIP Comments: 04/12/2017 WS - submerged in water, inspected by JK, RF. (DWR Sacramento Yard - C. Lund) FIELD_STRUCT_DESC: 24-inch corrugated metal drainage pipe through the levee, 17.5 feet below the crown. Flap gate is located on the waterside (WS) end. Concrete headwall with wing walls is located on WS. (24-inch pipe [HLM 5.32] authorized under Automatic Board Order (ABO) issued as Permit No. 10322, 1974 - Chew). [Additional Reference(s): DWR Levee Log, 1990. USACE Sacramento O&M Manual Unit 120, Willow Slough Channel Relocation and Levee Construction, February 1947, Drawing No. 50-4-2281 Sheet 4 (Station 287+19)] FS Date: 5/14/2015 1:44:30 PM

Waterside view- overview

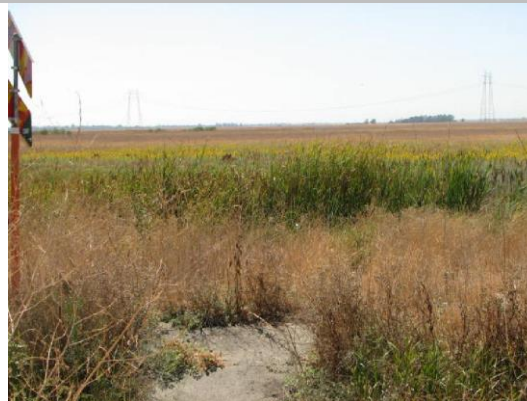
Photo 3 of 3 : UCIP_SP_2019_45307_22870.jpg

Comment Code						
Inspector Comment						
FS_ID:45307 DS_ID:553 EP_NO: 10325 Repair Type: No Action Needed Crossing Status: Found UCIP Comments: 04/12/2017 WS - submerged in water, inspected by JK, RF. (DWR Sacramento Yard - C. Lund) 09/20/2012 Outlet structure under water in waterside of the levee. No access to the inlet structure. (DWR UCIP - P. Amatya) FIELD_STRUCT_DESC: 24-inch corrugated metal drainage pipe through the levee, 18 feet below the crown. Flap gate is located on the waterside (WS) end. (24-inch pipe [HLM 5.98] authorized under Automatic Board Order (ABO) issued as Permit No. 10325, 1974 - Ferris) [Additional Reference(s): DWR Levee Log, 1990. USACE Sacramento O&M Manual Unit 120, Willow Slough Channel Relocation and Levee Construction, February 1947, Drawing No. 50-4-2281 Sheet 4 (Station 328+51)] FS Date: 5/14/2015 1:45:44 PM

Landside view- overview
